CLIENT:
BSPS Ltd
Five Eastfields
London
SW18 1FU

PROJECT NO: S4132/CM

DATE: 28/01/2021

**ASBESTOS REFURSBISHMENT SURVEY
OF
9-11 & 13-15 GROVENOR GARDENS, WESTMINSTER, LONDON, SW1W 0BD**

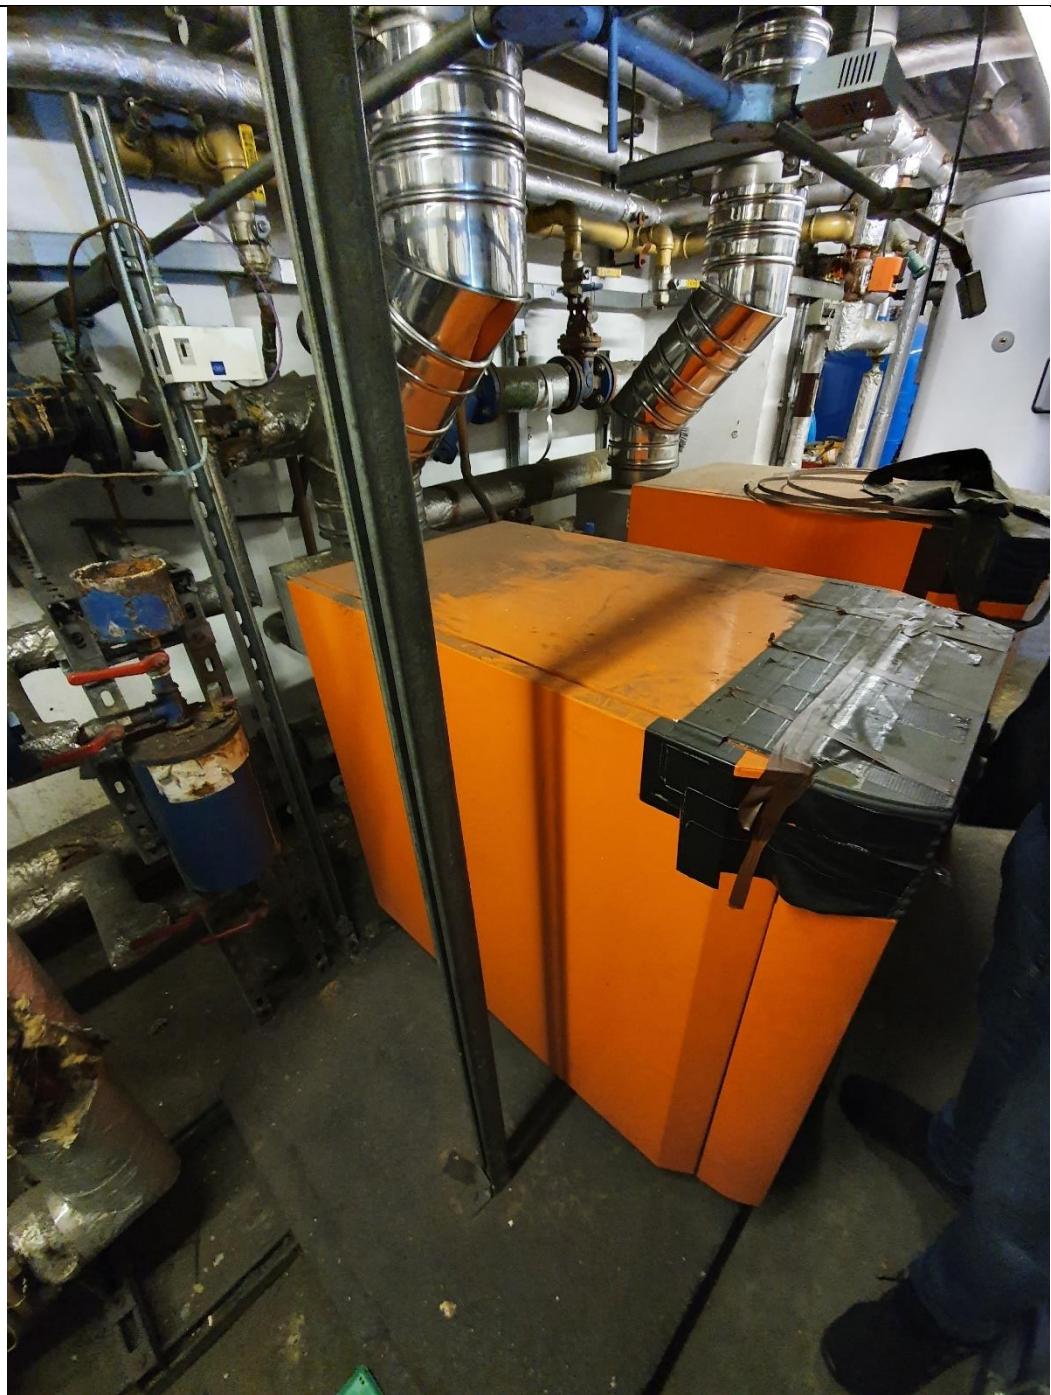
Boiler Room – Asbestos Debris to walls

Second/Third Floor	Floor tiles and Bitumen adhesive	Remove prior to any works commencement
Basement Boiler Room	Asbestos debris to walls	Remove prior to any works commencement

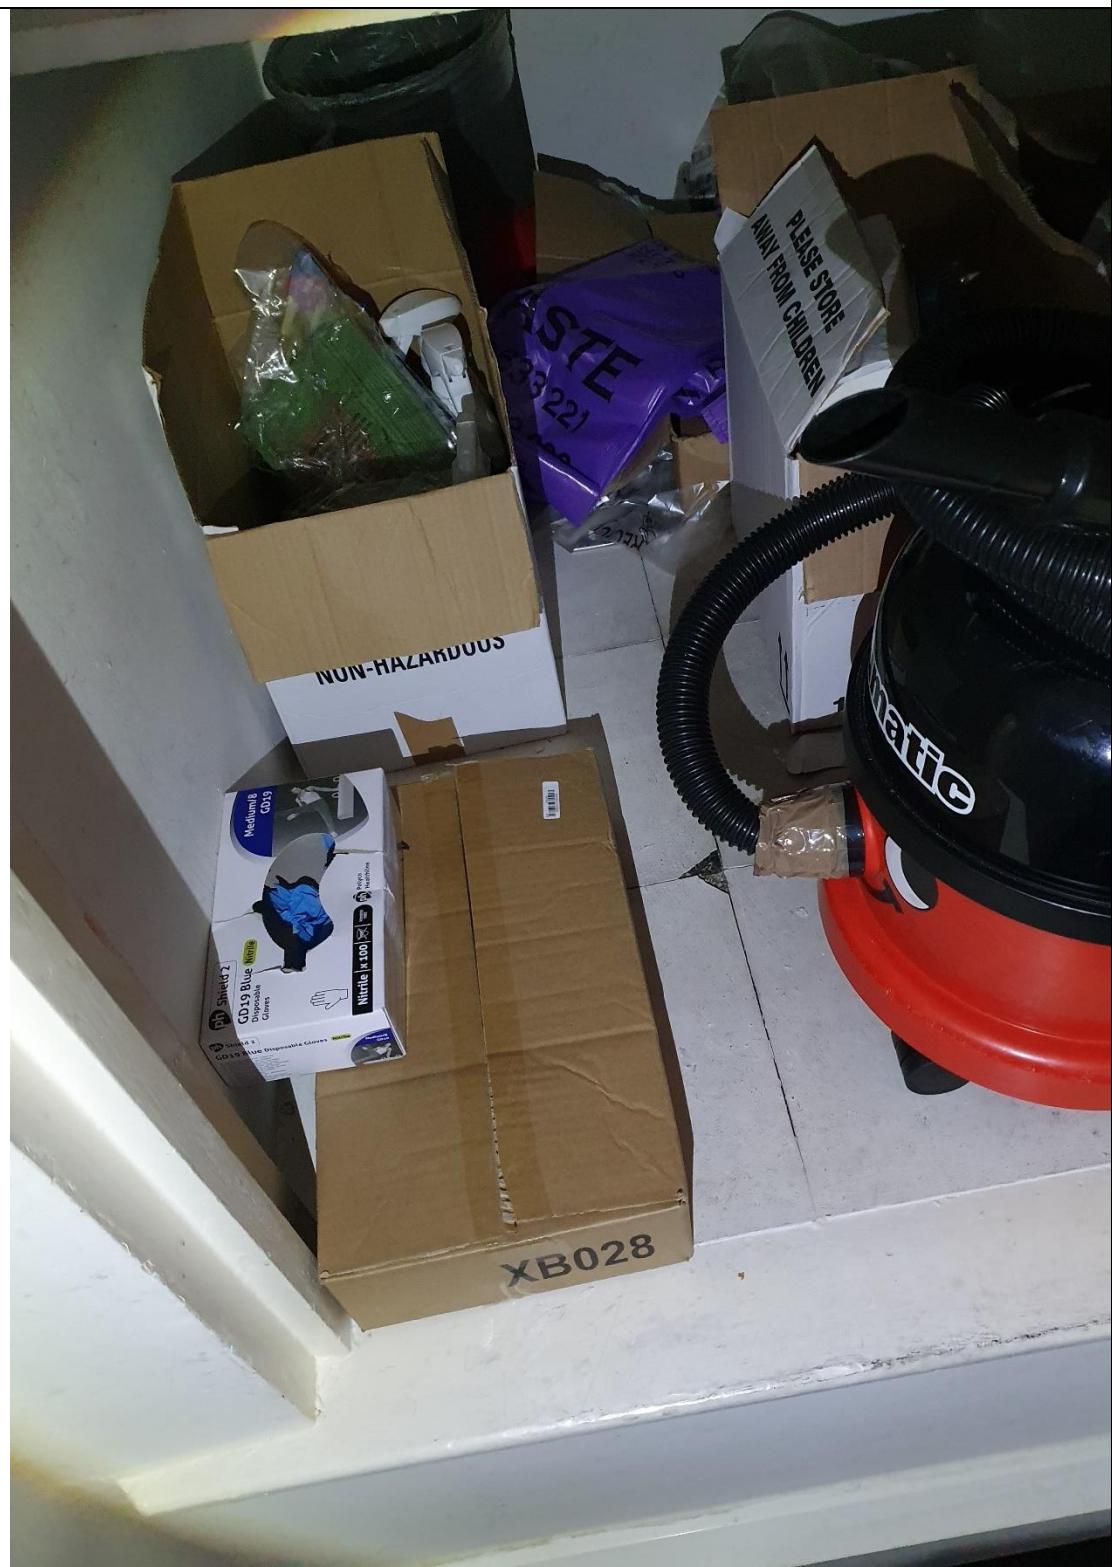
Second/Third Floor – Asbestos Floor tiles within cupboard

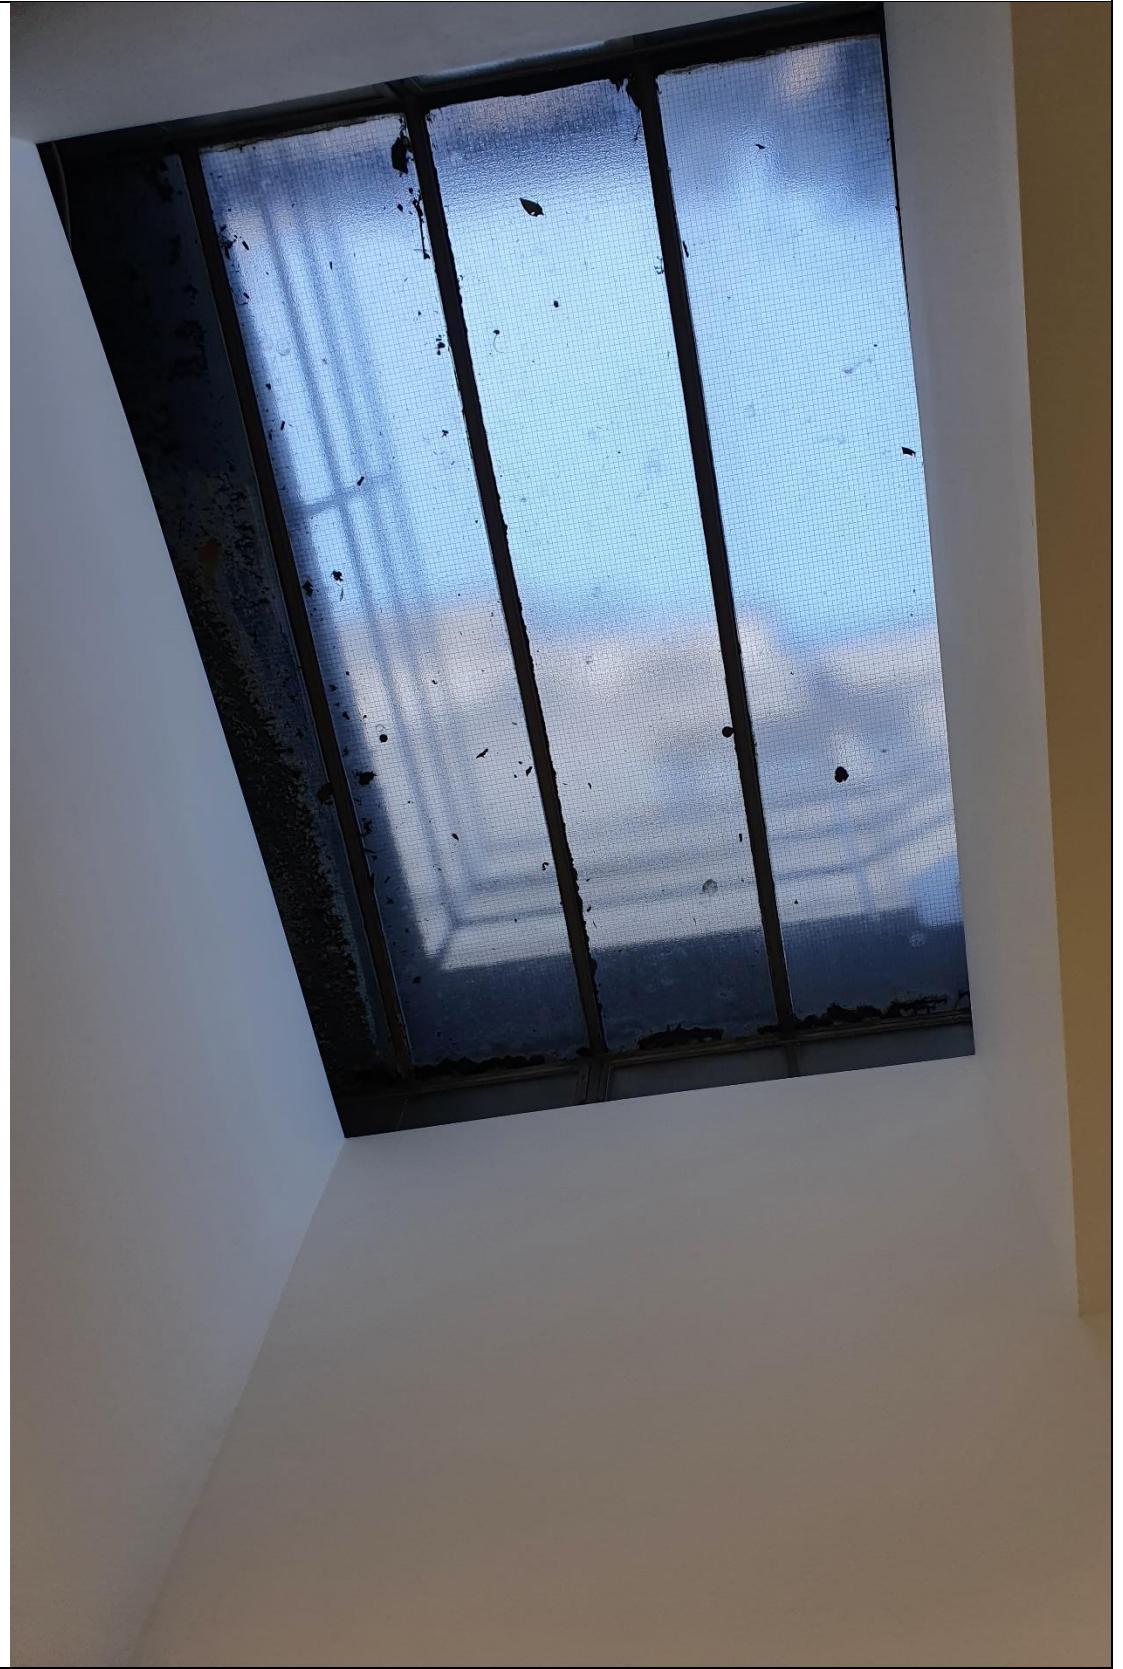
No Access to Skylight
